Manhole Inspection Summary

Manhole # S25M__001MH

Insp Date: **3/5/08 11:54 AM**

Location Address: **1352 Glyndon Avenue**

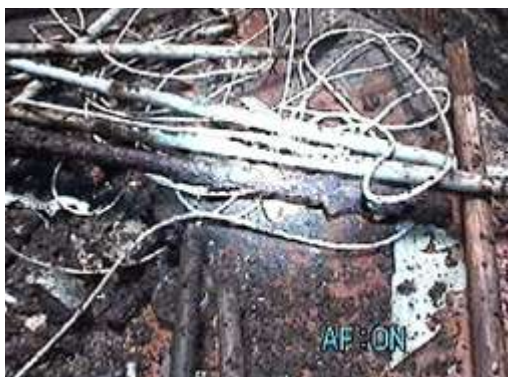
Defect 4

Condition: ☐ Sound ☐ Cracked ☐ Root Intrusion ☐ Deteriorated ☐ Leaks ☒ **Debris**

Debris in manhole

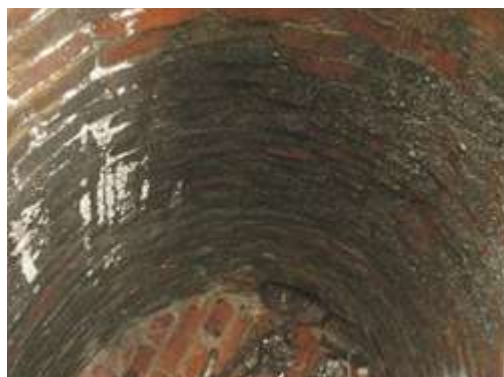
Defect 3

Infiltration: ☐ None ☐ Joint ☐ Cracks ☐ Mortar ☐ Roots ☒ **Wall**

barrel infiltration

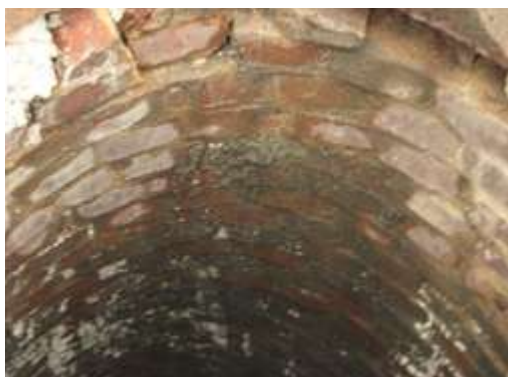
Defect 2

Infiltration: ☐ None ☐ Joint ☐ Cracks ☐ Mortar ☐ Roots ☒ **Wall**

corbal infiltration

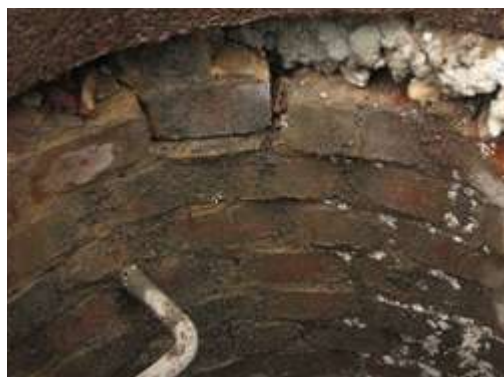
Defect 1

Condition: ☐ Sound ☐ Cracked ☐ Root Intrusion ☒ **Loose Brick** ☐ Deteriorated

Infiltration: ☐ None ☐ Joint ☐ Cracks ☐ Mortar ☐ Roots ☒ **Wall**

loose bricks and missing mortar

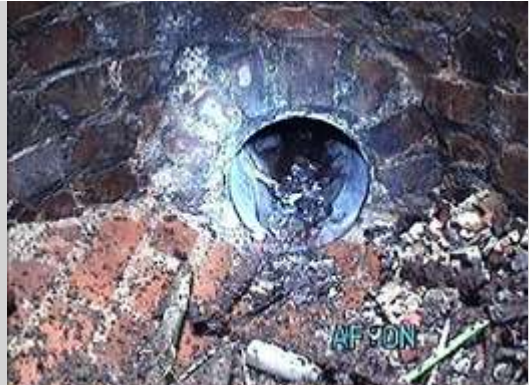
12 O'Clock Outflow

Deposits: ☐ None ☐ Mud ☐ Sludge ☒ **Debris** ☐ Grease

Silt Depth: **0.5** (in.) Deposits Extent: **Light**
